This consists of the following Bosch components:

3.1983
(Replaces Ed. 1.1982)

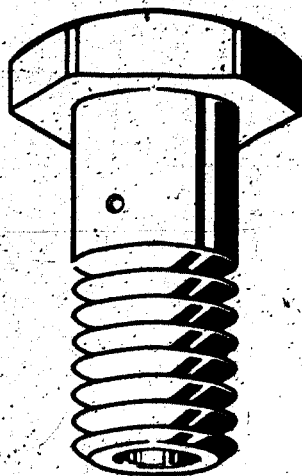
Fig. 1

Distributor-type fuel-injection pumps (VE) for Opel Kadett and Ascona Diesel are not fitted with overflow throttles (Fig. 1), but with overflow throttle fittings (Fig. 2 - Opel part).

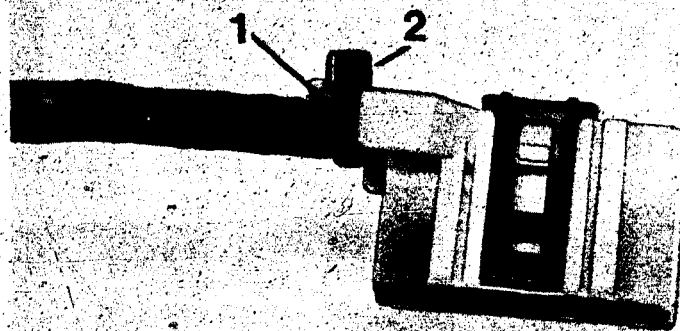
- 1 = Handle cover of trip computer plug (26-pin)
- 2 = Clamping band

When replacing trip computers 0 263 001 000/001, ..002/003, ..006/007 ..008/009, ..010/011, ..014/015 with versions ..022/023, the original Opel wiring harness must be converted as follows:

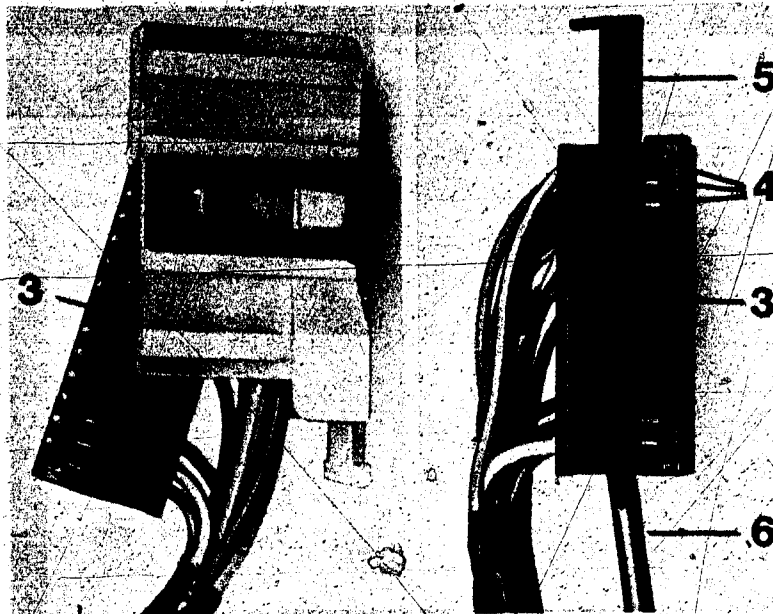
3 = Contact support 5 = Locking piece
4 = Minitimer 6 = Screwdriver

- Pull contact support (3) out of handle cover.
- Using a thin screwdriver (6), press locking piece (5) out of contact support (3).
- Insert code lead into trip computer plug in accordance with the following table (required as external wiring-harness coding for trip computers 0 263 001 022/023).

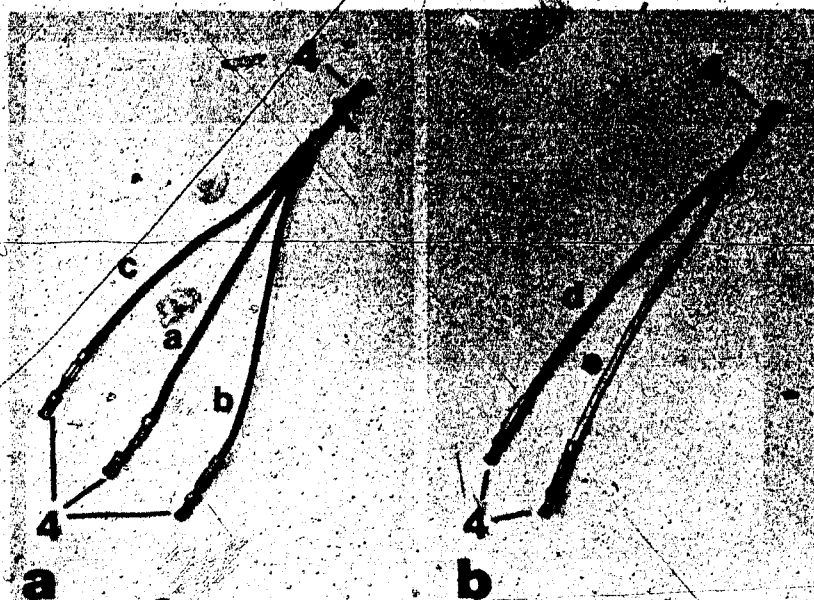
Fig. a = Code lead 1 Fig. b = Code lead 2

2 code leads with attached minitimers are enclosed with the aftermarket versions of the trip computer. In addition, a new cover for the operator control panel (without illumination button) is enclosed. It can be changed after loosening 3 screws on the underside of the operator control panel.

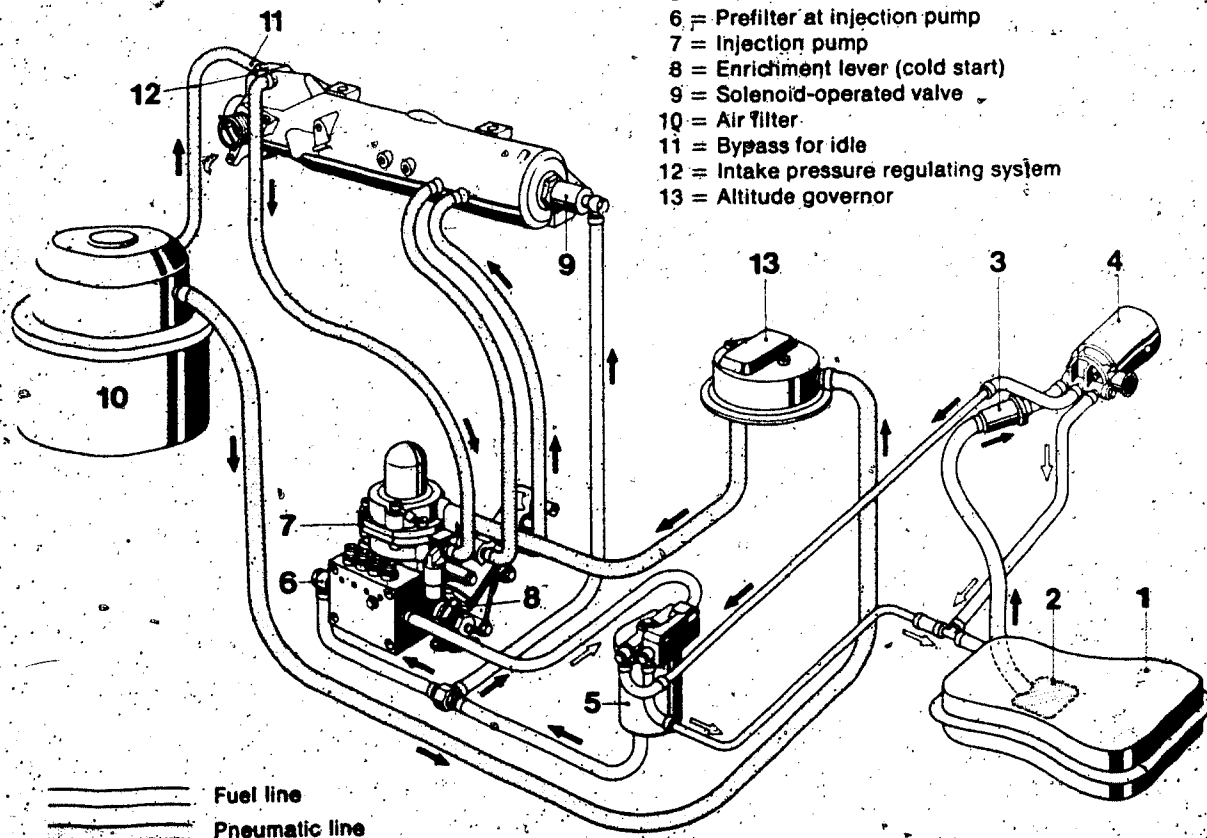
In order to ensure that exhaust gas regulations contained in the "Europe Test" can be met in the future, the cam lever in the A5 design of the injection pump was designed so that fuel injection is not cut off during overrun. In addition, the amount of fuel injected into the engine during idle was reduced. The cam lever has the designation A-006, 8 492 530 494. Contrary to the information given in the explanation of the pump type coding, the A5 and A6 designs cannot be replaced with designs A1 through A4. We recommend that as a basic rule you convert to the A5 or A6 design when a pump of design A1 through A4 must be repaired. In order to do this, the following changes must be made on the engine:

- The diaphragm with a diameter of 2.3 mm (black) installed in the air distributor must be replaced by the diaphragm with a diameter of 2.2 mm (brass color), Part No. 8491 102 220.
- The light gap in the throttle valve should be adjusted as described in the section "Adjusting the Pump to the Engine" below. After this adjustment has been made, the light gap should be enlarged by turning the idle stop screw $\frac{1}{8}$ of a turn inward. Set the idle speed and the CO concentration in the exhaust gases to the correct values.

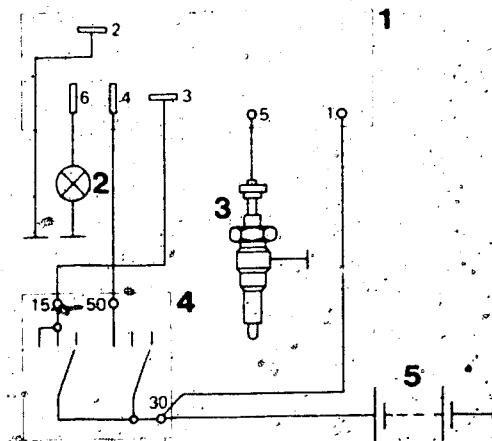
Terminal diagram

- 1 - Glow-duration unit
- 2 - Start repeater lamp (12 V max. 2 W)
- 3 - "R"-type sheathed-element glow plug
- 4 - Glow-plug and starter switch
- 5 - Battery

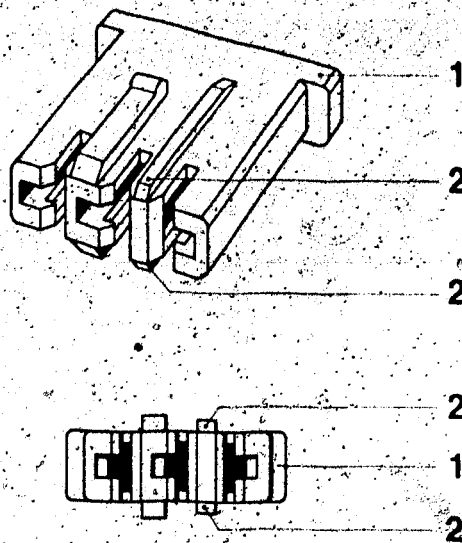
Fig. 1 Old design

1 = ignition-distributor connector
2 = long, narrow guide noses to be removed
